DEPARTMENT OF TRANSPORTATION

Contract #: 04-0120F4Cty: SF/ALA Rte: 80 PM: 13.2/13.9File #: 69.28**WELDING INSPECTION REPORT****Resident Engineer:**Siegenthaler, Peter**Address:** 333 Burma Road**City:** Oakland, CA 94607**Report No:** WIR-023256**Date Inspected:** 29-Apr-2011**Project Name:** SAS Superstructure**OSM Arrival Time:** 700**Prime Contractor:** American Bridge/Fluor Enterprises, a JV**OSM Departure Time:** 1900**Contractor:** Zhenhua Port Machinery Company, Ltd (ZPMC), Changxing Island **Location:** Shanghai, China

OBG TA YARD, Segment 13AE

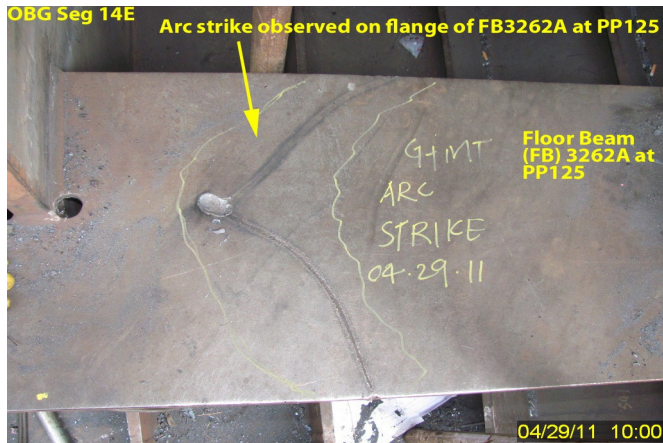
During a random in-process visual inspection of OBG member identified as segment 14E, this QA observed an arc strike on piece mark identified as Floor Beam (FB) 3262A. This QA marked the affected area and informed ZPMC

Quality Control (QC) indentified as Mr. Lv Li Qing of this issue. Mr. Lv Li Qing informed this QA that the arc strike would be corrected in a manner compliant with the contract documents. See attached photograph for further details.
